University of Pennsylvania
TEC2 Next Level
November 2016

Case study: broken instrument

Dr. Claudia Michl, M.Sc.

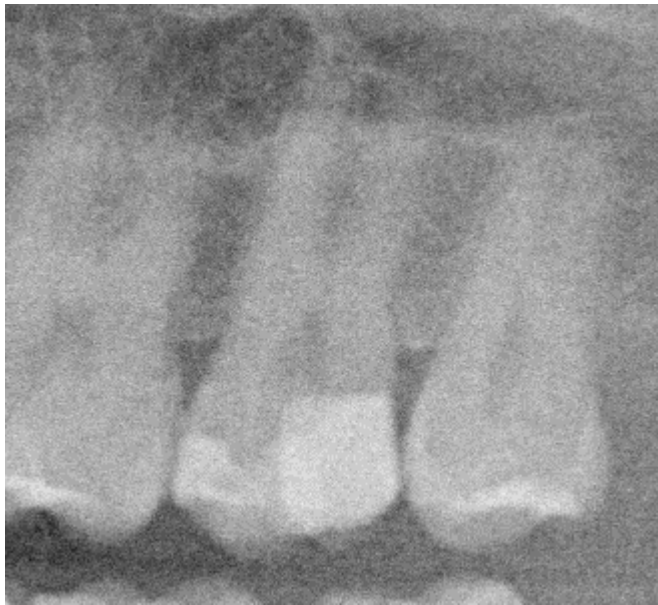
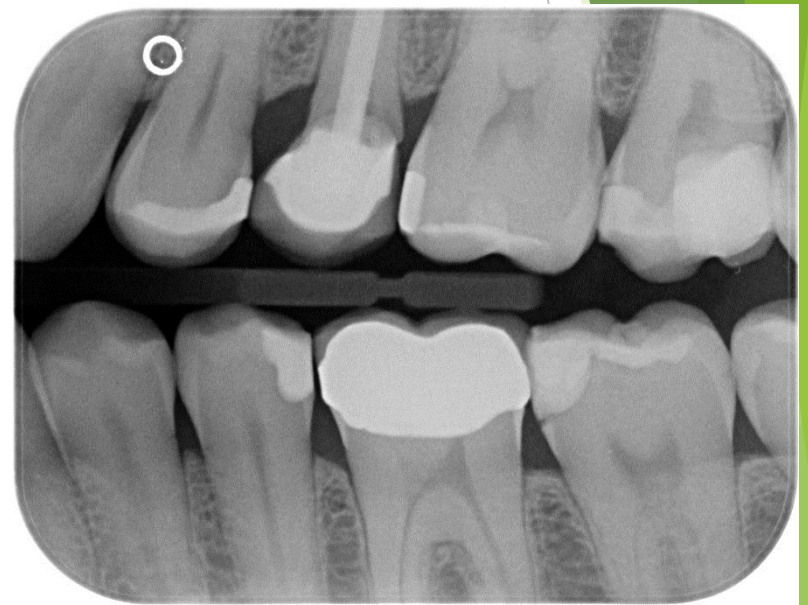
Starting point

- ▶ 43 year old patient with acute pain in 2. quadrant
- ▶ OPG area 26 to 27:
 - ▶ Tooth 27: occlusal distal shows filling next to pulp as well as occlusal mesial another filling with other material, which seem to be mesially insufficient
- ▶ X-ray: periradicular as well as apikal with no clinical report
- ▶ Filling at 27 occlusal -distal: was exchanged 3 days ago due to acute pain of the patient

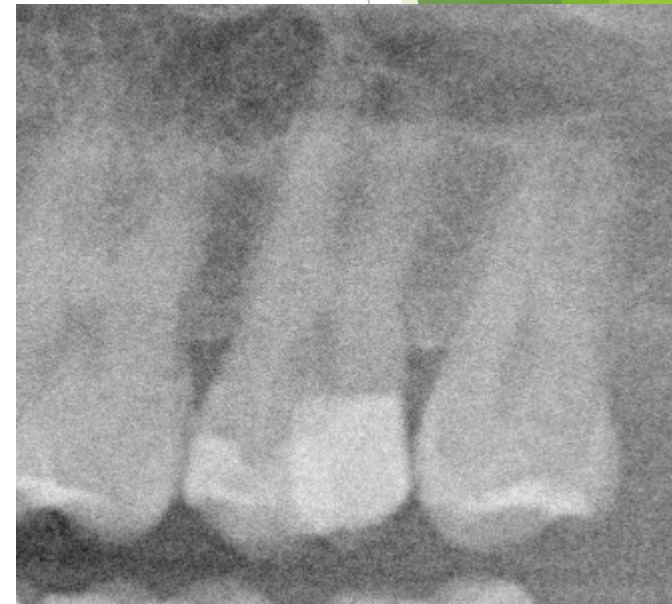
X-ray upon endometric legth measurement

Distal Chanel: remarkably curved to distal

During straight approach towards the channel, the BRO file of Biorace cracked in the middle third of the distal channel

- ▶ During the preparation of the access cavity, a crack of the instrument (BR0 file, BioRaCe Systems) at the distal root occurred
- ▶ The top of the file of the rotary instrument got stuck within the lower middle channel third. This was caused by a pronounced root curvature of the distal channel as well as the insufficient straightening of the entry cavity before insertion of the rotary instrument

- ▶ The instrument fracture was due to exceeding torsion forces of the NiTi file with the channel lumen. The patient was informed immediately upon the accident and a X ray was recorded to investigate the location of the instrument within the channel

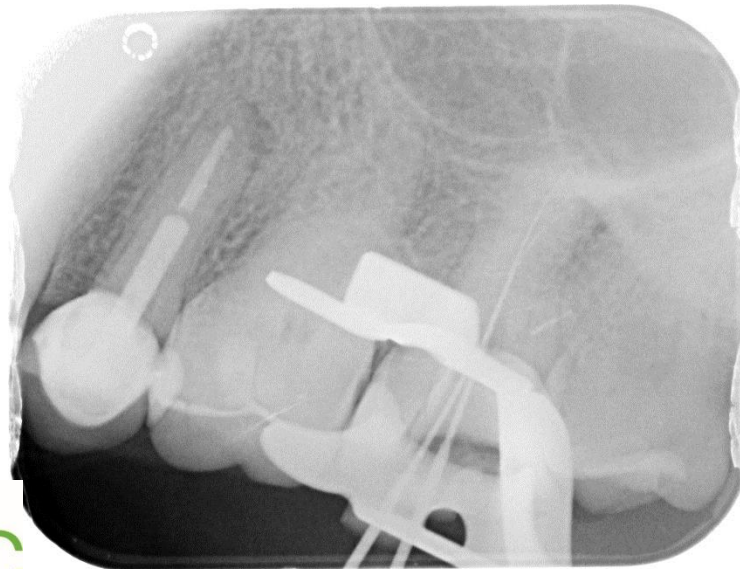
X-ray upon endometric legth measurement

X-ray mesial eccentric

Mb1: 19mm (Iso10 R)

Pal: 19mm (Iso 20 R)

Db: Fracture BRO File

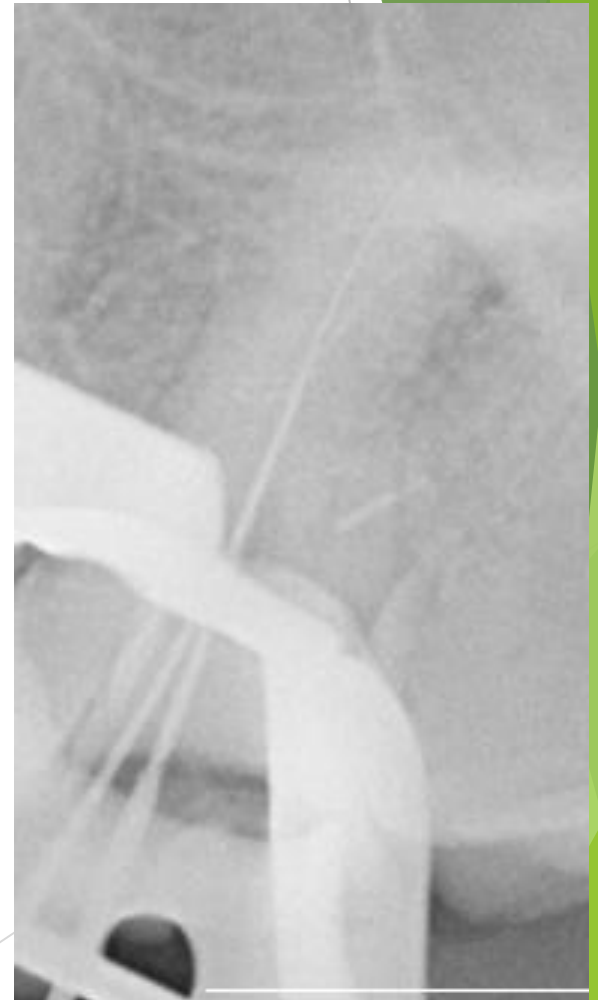
Removal of fragment via surgical microscope via ultrasonic technique

- ▶ Broadening and straightening of coronal entry with cut Gates-Glidden 2 → coronal part of fragment is visible
- ▶ circular vibrating of fragment via Endo- Chuck Needle
- ▶ Irrigation with EDTA 17 %

- ▶ The instrument could be removed successfully via the dental microscope and ultrasonication

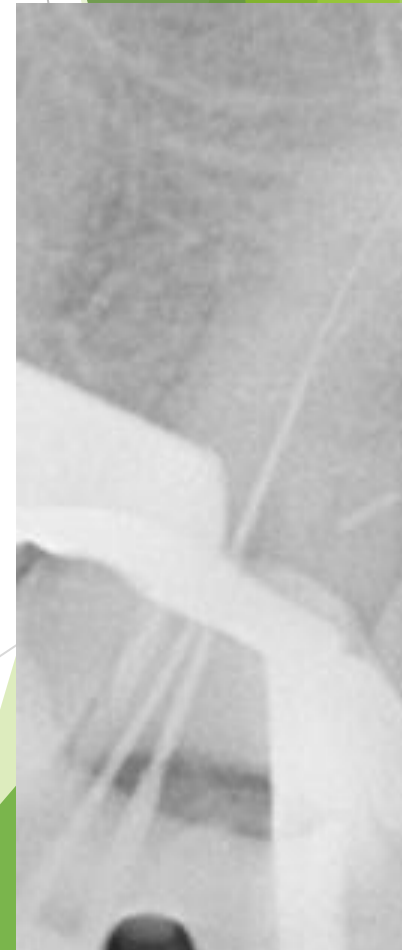
Cracked BR-0 Instrument removed and X-ray Disto-buccal

► Db: 19mm (Iso 15)

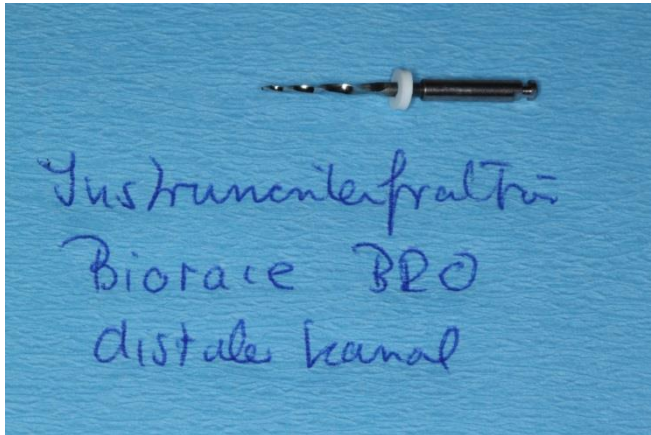
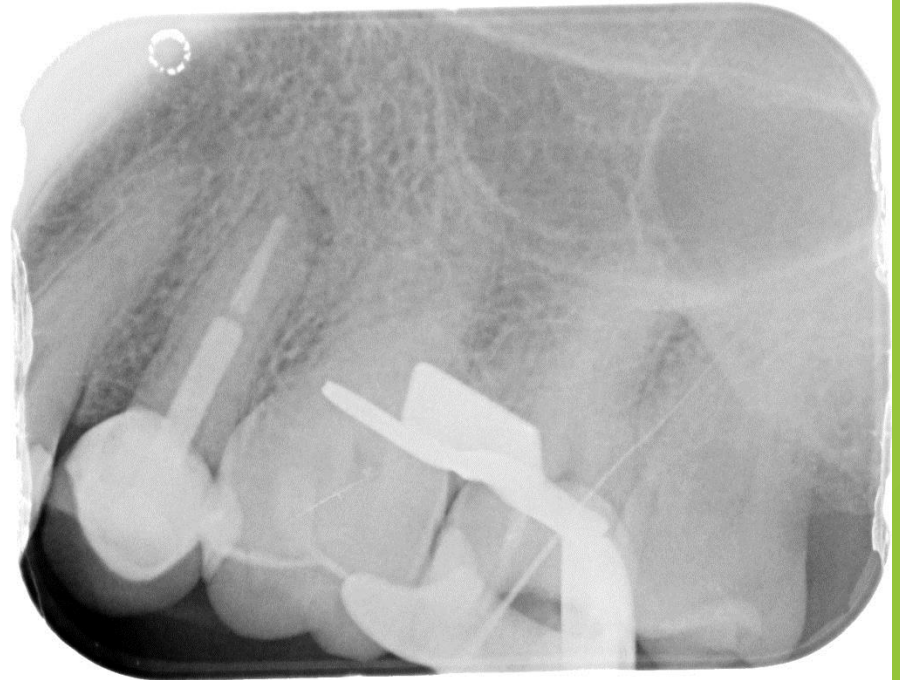
Apical Sizing

- ▶ Initial rotary File
- ▶ Mb1: Iso 10
- ▶ Db: Iso 15
- ▶ P: Iso 20

final apiakal Size

MB1: Iso 35

Db: Iso 35

P: Iso 40

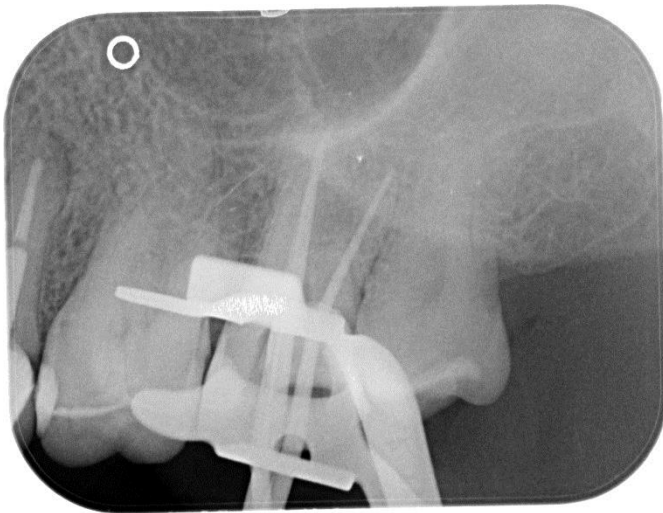
posttreatment radiograph

- Opturation and cover the floor of the pulp chamber with a line of bonded material after removal of excess gutta-percha to the canal orifice

The channels of tooth 27 could be treated thoroughly and filled completely
